UNITED STATES
NUCLEAR REGULATORY COMMISSION
OFFICE OF INSPECTION AND ENFORCEMENT
WASHINGTON, D.C. 20555

IE Bulletin No. 79-09

FAILURES OF GE TYPE AK-2 CIRCUIT BREAKER IN SAFETY RELATED SYSTEMS

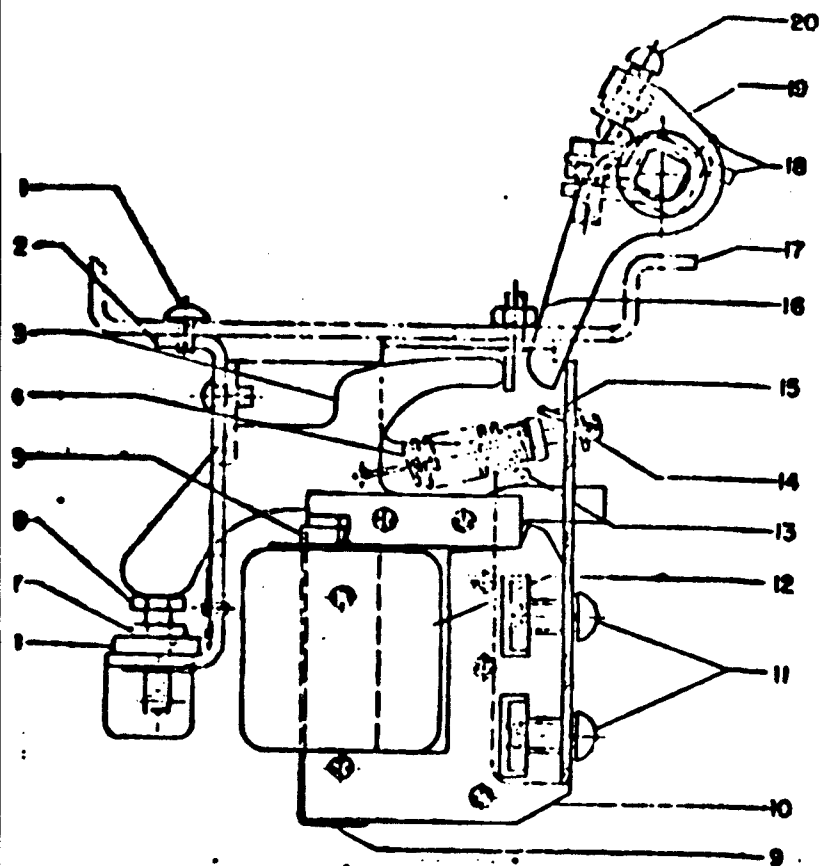
AK-2-15 and AK-2/3-25 Undervoltage Tripping Device

The causes for failure were attributed to either binding within the linkage mechanism of the undervoltage (UV) trip device and trip shaft assembly or out-of-adjustment conditions in the same linkage mechanism. Babcock and Wilcox (B&W) and GE determined that the binding and out-of-adjustment resulted from inadequate preventive maintenance programs

1. Check the undervoltage trip device to assure there is not excessive clearance between the armature and the rivet and that there are no binds as the armature moves through its travel when manually operated. If excessive clearance or binding exists, it should be adjusted by loosening screws (11) and moving the magnet (10) up or down as necessary to obtain the proper freedom of the armature (3) with respect to its pivot on magnet (10) and the guide provided by rivet (13).

To adjust the pick-up of the instantaneous undervoltage trip device, remove the Locking Wire (15) and turn the adjusting screw (14) clockwise to raise the pick-up to the desired setting. A suitable voltmeter and adjustable voltage source should be connected to the undervoltage device coil leads at the terminal board for stationary breakers or the secondary disconnects for drawout type breakers. On AC devices, the pick-up voltage should be read immediately before the armature closes its air gap. After the pick-up is adjusted, locking wire (15) should be installed.

5. The adjustment between the undervoltage trip device and the trip paddle on the trip shaft should be checked to assure the required positive trip is maintained (positive trip exists when approximately 1/32 inch additional travel of the armature occurs after the undervoltage device trips the breaker). This adjustment is made with adjusting screw (20).
